# **Demonstration of Innovative Sewer System Inspection Technology: SL-RAT™**

Contract No. EP-C-11-006

National Risk Management Research Laboratory  
Office of Research and Development  
U.S. Environmental Protection Agency  
Cincinnati, Ohio 45268

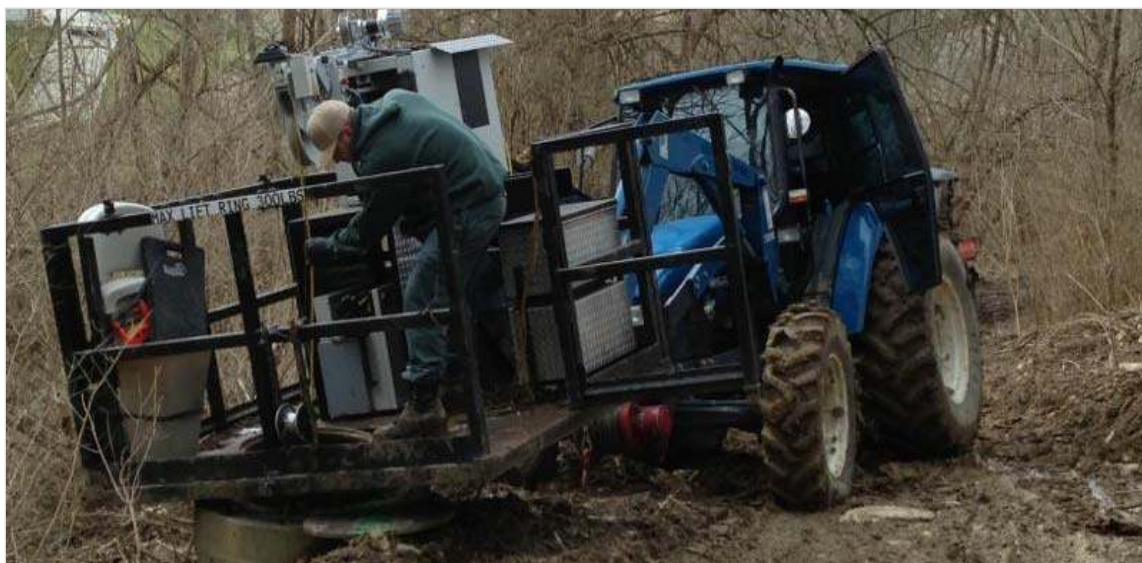
The most common type of robotic CCTV inspection systems in use for inspection of public sewers requires vans, trucks, or similar vehicles for their operation. If sewers are located off-road, all wheel drive or four wheel drive vehicles may be required to access the manhole structures. A new vehicle equipped with a CCTV inspection system will typically cost between \$100,000 and \$200,000, and require a minimum crew of two persons. Custom off-road vehicles equipped with CCTV systems are even more expensive to own and operate. Figure 1-1 shows a custom off-road CCTV camera tractor owned and operated by the Metropolitan Sewer District of Greater Cincinnati (MSDGC).

**Figure 1-1.** Custom Off-road CCTV Camera Tractor (Courtesy: MSDGC).

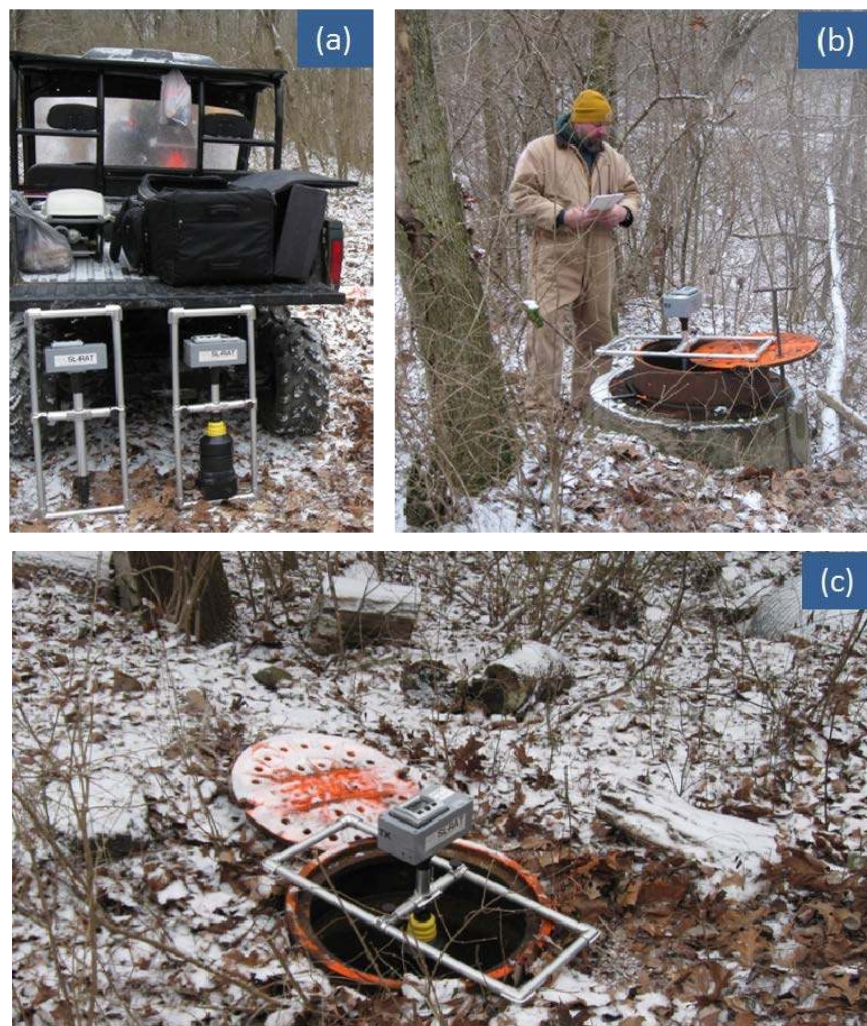
time and allows the units to be ready for operation. Figure 1-3(a) shows the SL-RAT units in their transport mode at one of the EPA study sites. To perform an acoustic inspection with the SL-RAT, the manhole covers at both ends of a pipe section are either partially or fully removed. The SL-RAT units are then placed in their operational mode as depicted in Figure 1-3(b) and (c) for the RX and TX units, respectively. For off-road or on-road inspections, the SL-RAT can be easily transported manually with the RX unit weighing 11 pounds and the TX unit weighing 18 pounds. Typical usage involves inspecting multiple pipe segments along a leg of a sewer line. This is facilitated by only moving one unit at a time after each inspection (effectively “leap frogging” the units down the sewer line). Tests are conducted while the pipe is in operation, with no need to restrict or change the flow conditions. The units can be deployed for testing in either the upstream or downstream direction.

**Figure 1-3.** SL-RAT Deployment at EPA Project Site: (a) TX and RX Units in Transport Mode, (b) RX Unit Operational Mode Deployment, (c) TX Unit Operational Mode Deployment.
